MAINSTREAMING WILDLIFE
INCIDENT MANAGEMENT
INTO UTILITIES IN EAST AFRICA

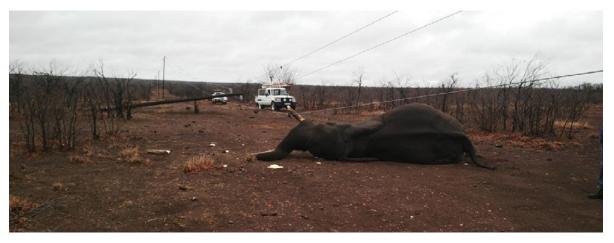
Elephant electrocuted by a low-hanging conductor. Photo credit: The EWT

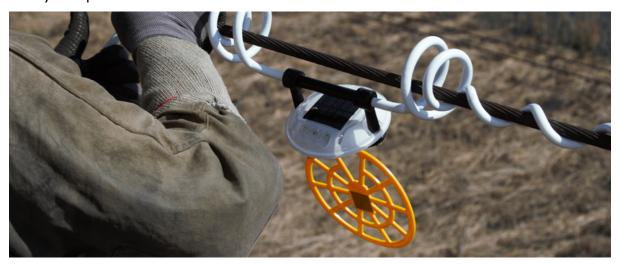
The OWL nocturnal bird flight diverter with flashing LED lights, intended to be visible to nocturnal flying birds so that they can avoid colliding with the power line. Photo credit: Matt Pretorius

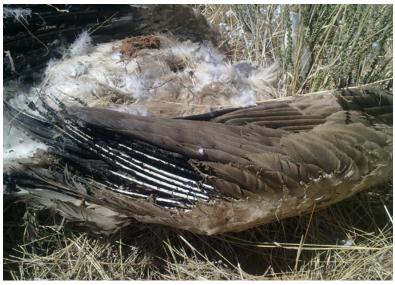
A White-backed Vulture electrocuted on a distribution line structure. Note the burn marks on with wings, with singed feathers. Photo credit: Ronelle Visagie.

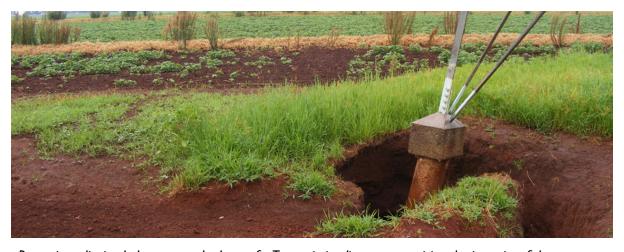
Porcupines digging holes next to the base of a Transmission line, compromising the integrity of the structure.

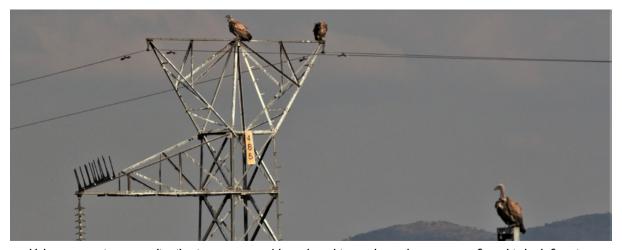
Vultures roosting on a distribution structure. Note the whitewash on the structure from birds defecating. Photo credit: Constant Hoogstad

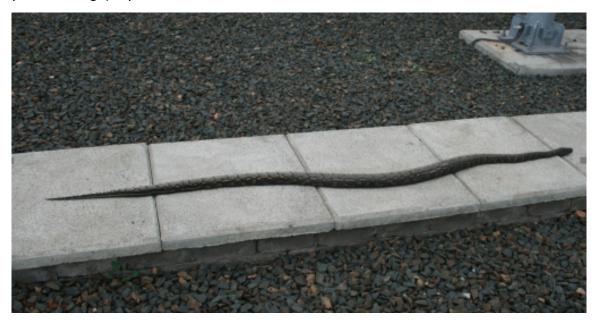
African Rock Python electrocuted in a substation. Photo credit: Eskom

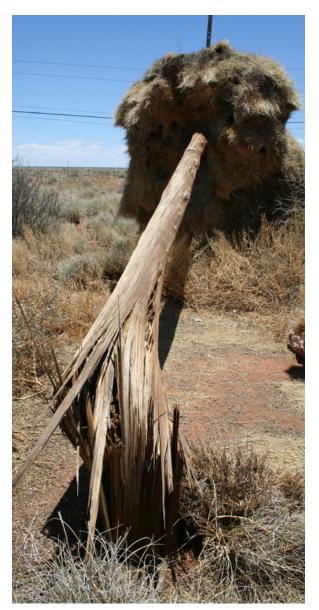
Sociable Weavers build nests that often weigh up to 1,000 kg, causing wood distribution poles to break due to the weight. Photo credit: the EWT

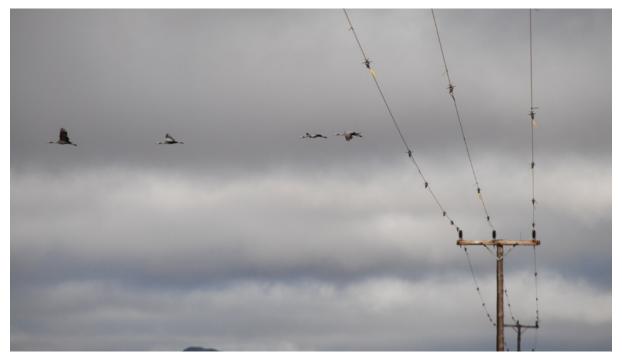
Blue Cranes passing over a Distribution line marked with bird flappers. Photo credit: Marianne Golding

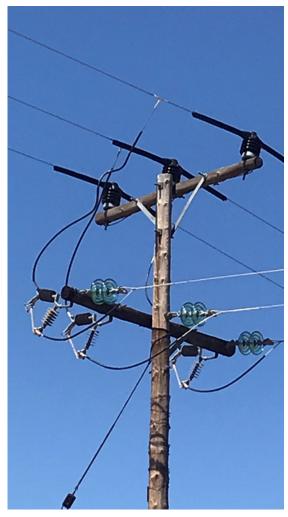
Raptor protectors and insulated jumpers on a distribution pole. Photo credit: Constant Hoogstad

Wildlife 'friendly' power structures maximize the separation between phases and earthed components. For horizontally configured phase designs, suspending the outer phases below the cross-arm of a power pole greatly improves phaseto-phase separation. For vertical configurations, the vertical separation between phases should be increased to safe levels. Utilities can use angled beams or brackets to make it difficult for birds to perch near energized or earthed components comfortably, thereby discouraging their use of the pole/tower; however, these should be used cautiously as they may also provide an angle where nests can be built next to the main pole.

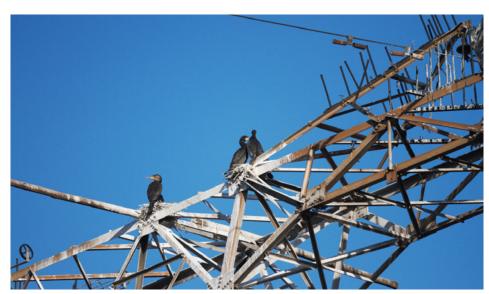
Reed Cormorant nesting on a transmission tower, causing pollution and streamer problems. Photo credit: Matt **Pretorius**
